Site Systems Support Bulletin 025

This bulletin references an issue where the SPOT reports one Bios version but the Bulloch reports another
This Bulletin applies to OTC sites, new installation with EMV outside enablement or SPOT replacements.

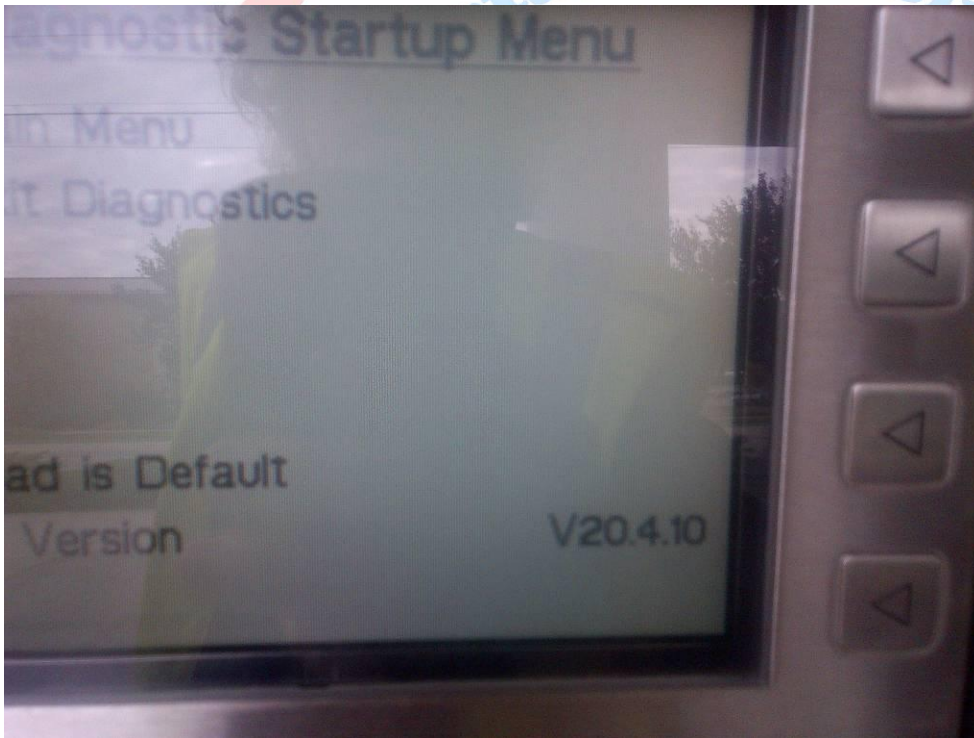
Ex: A technician was performing an EMV enablement of AFD as part of a dispenser replacement. The Technician had ensured the SPOTs had the proper package loaded and verified with his diagnostic test card. When he rebooted the Bulloch in order to get the Red Automation screen to appear the screen never displayed, and the AFD's took the normal non EMV download. As a result EMV was not activated at the AFD.

This is what the SPOT showed on a Diagnostics card insert:

If this situation applies to you contact GVR TAC and report this issue, they will work with you to find a resolution. In some cases a SPOT replacement is the only solution.
