iX™ Pay Secure Payment Module

This service memo has been created in order to reinforce or bring light to specific steps and practices that may reduce the frequency of return visits for the iX Pay solution. Please ensure this memo is disseminated to all ASOs certified to work with the iX Pay solution.

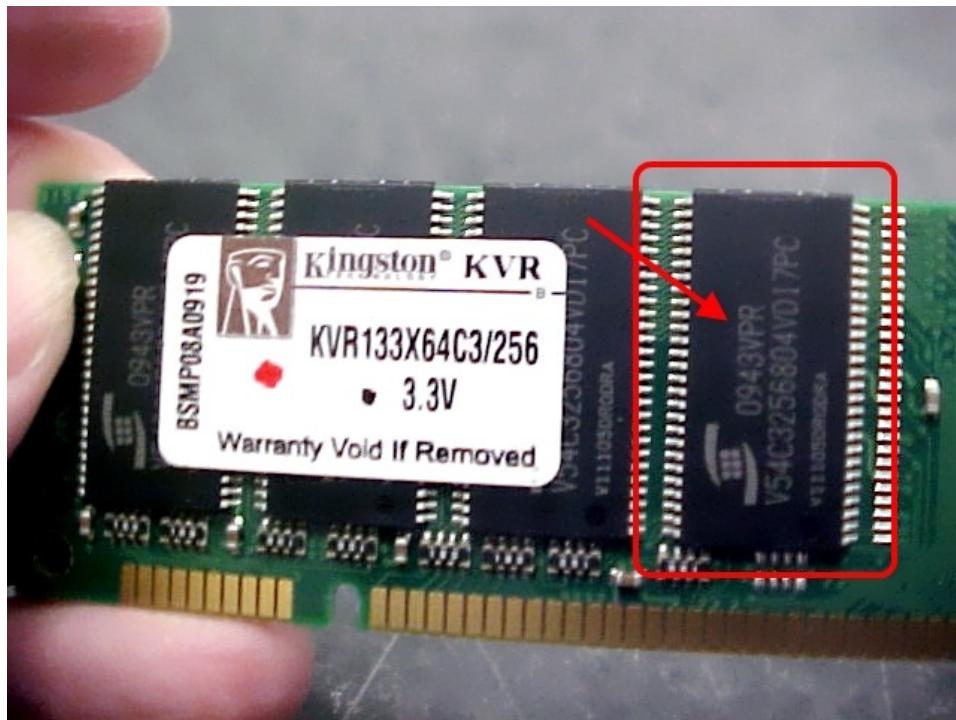
Some of the issues with screen blanking and black lines on the displays of iX board dispensers are believed to be tied to a batch of bad RAM DIMMs on the iX board. When you see one of these issues in the field while working on these chronic sites, look at the RAM stick on the board.

The suspected bad RAM has the following component chips. Note the logo on the black component chip and where it shows "VPR" in the top line of text. Refer to Figure 1, below.

Figure 1: Suspected Defective Memory DIMM, with component chip and letter code VPR highlighted
