Introduction

This manual provides field technicians with clear troubleshooting steps to minimize unnecessary replacement of hardware, thus saving the personnel time and effort spent on service calls, while decreasing unnecessary hardware returns.

This manual has been divided into following troubleshooting sections: Tribrid Card Reader (TCR™), Hybrid Card Reader 2 (HCR 2), EMV® Keypad, Secured PIN Pad for Outdoor Terminal (SPOT) Display, host issues, other devices, and Point of Sale (POS). Within each section, there is a list of symptoms that can be observed on the component itself or related to it.

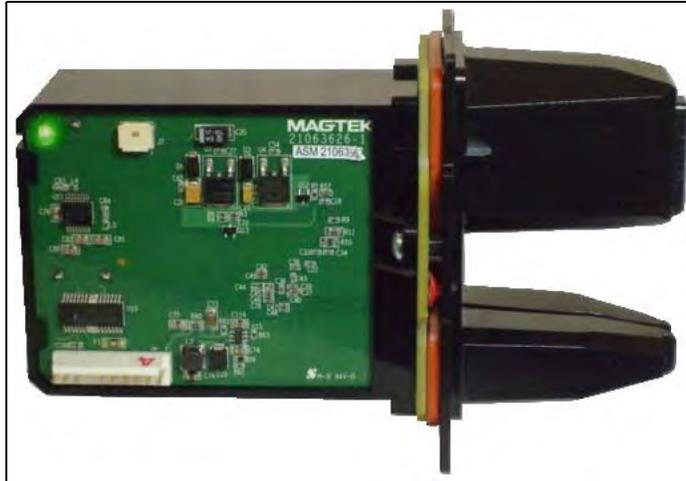
Figure 1 shows the HCR 2 Card Reader.

Figure 1: HCR 2 Card Reader

Following table lists the LED matrix for the HCR 2 Card Reader:

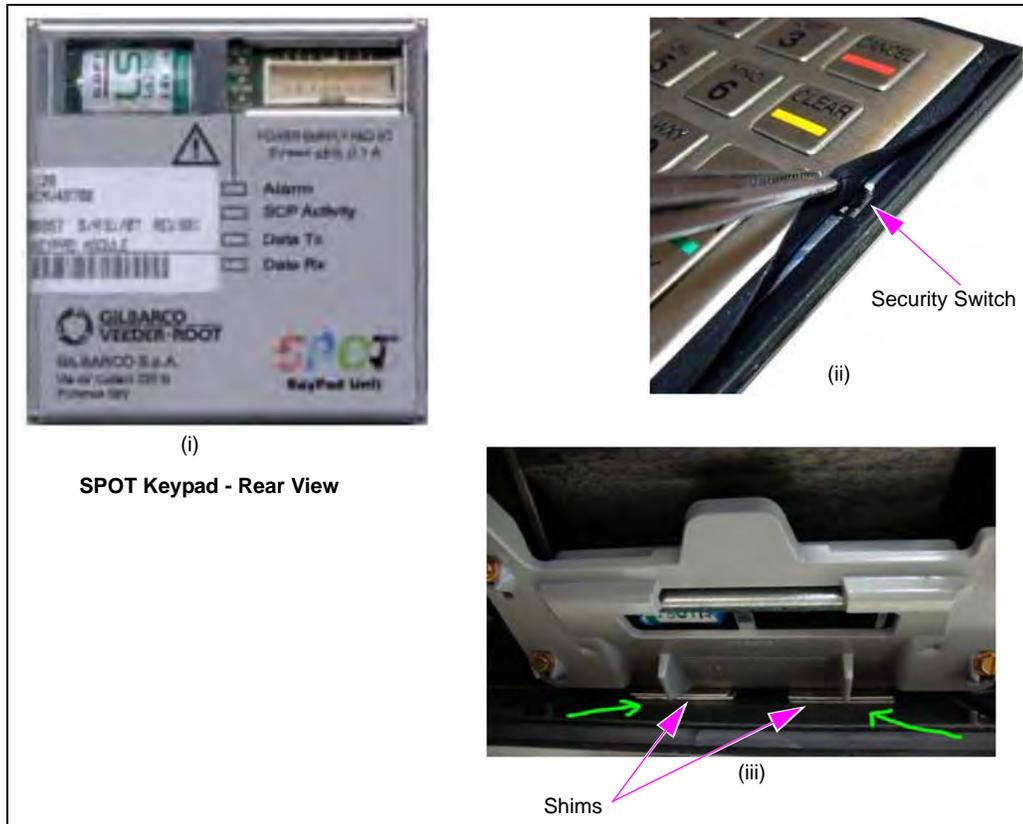
Figure 2 shows the EMV Keypad.

Figure 2: EMV Keypad - Rear View, Security Switch, and Shims

Following table lists the EMV Keypad LEDs and their descriptions:

LED	Color	Status	Check	Description
Alarm	Red	On		Item suffers a tamper tentative. The system does not work, it is "out of order". It needs to be replaced and must be sent to the factory.
		Off		Normal function.
SCP Activity	Green	Flashing		Security microprocessor program works properly. Flashing period is about 1 second.
		Off/On		The program is stuck.
Data TX	Red	Flashing		Item transmits data toward the display module.
		Off		The system does not transmit data on the gate.
Data RX	Green	Flashing		Item receives data from the display module.
		Off		The system does not receive data on the gate.

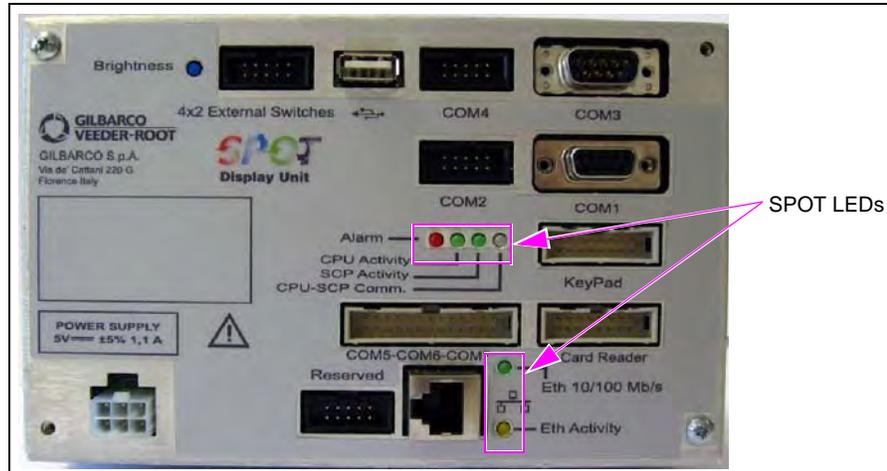
Figure 3 shows the EMV SPOT Display.

Figure 3: EMV SPOT Display

Following table lists the SPOT Card Reader LEDs and their descriptions:

LED	Color	Status	Check	Description
SCP Activity	Green	Flashing		The security microprocessor program works properly. Flashing period is about 1 second.
		Off		The program is stuck.
Alarm	Red	On		Item suffers a tamper tentative. The system does not work, it is "out of order". It needs to be replaced and must be sent to the factory.
		Off		Normal function.
Data TX/RX	Red	Flashing		This status shows the security microprocessor receives/transmits data from/to the display module.
	Green	On/Off		The security microprocessor does not receive/transmit data on the gate.
Card Reader TX/RX	Red	Flashing		This status shows the item receives/transmits data from/to the Card Reader module.
	Green	Off		The system does not transmit data on the gate.
24 V Present	Yellow	On		The 24 V power is present on the board.
		Off		The 24 V power is not present on the board. If the power supply is provided with the right voltage, it means the internal fuse is broken.

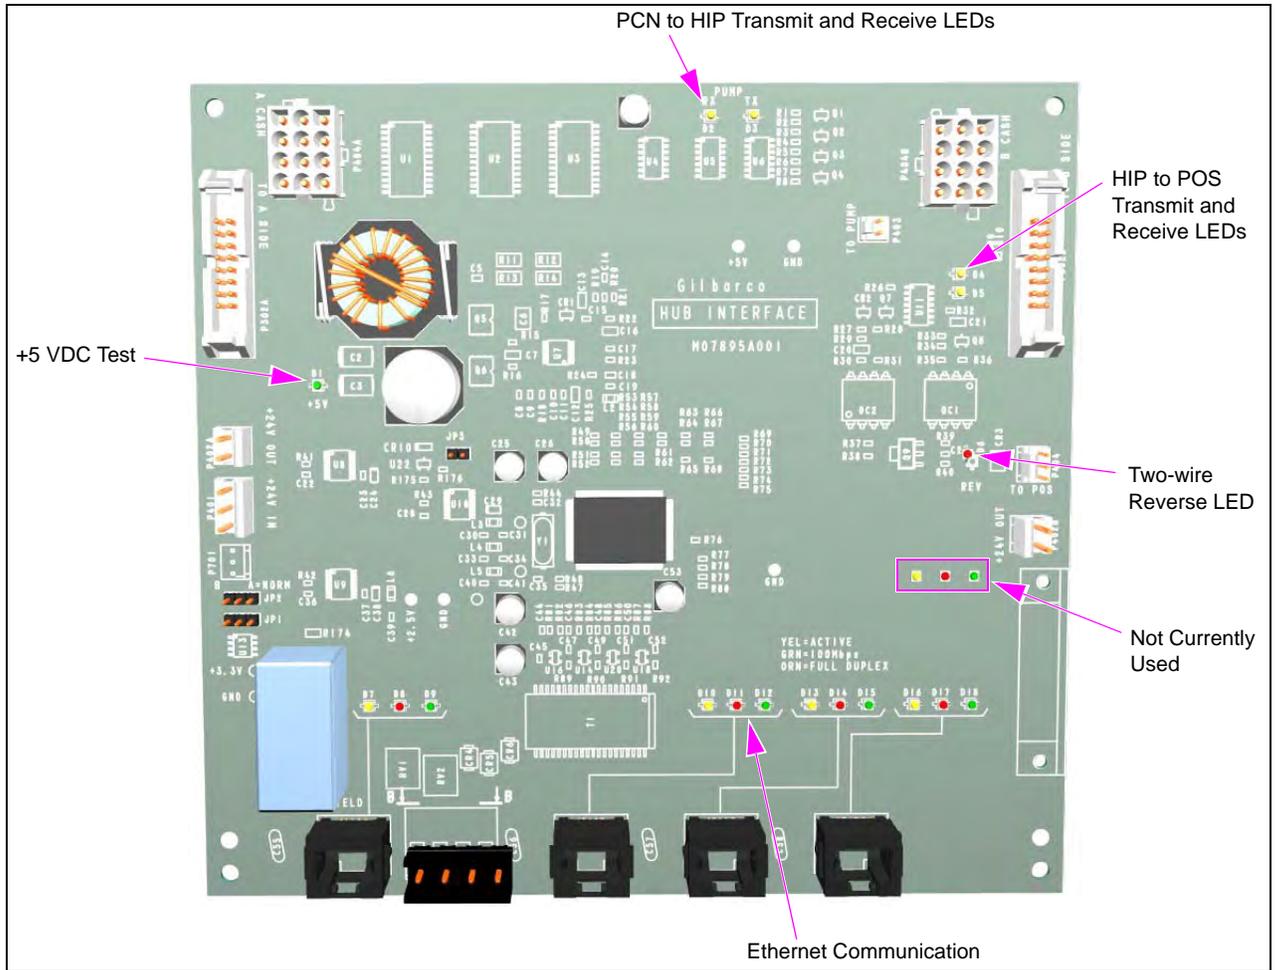
Figure 4 shows the HIP Board.

Figure 4: HIP Board

Following table lists the HIP Board ports and their connections:

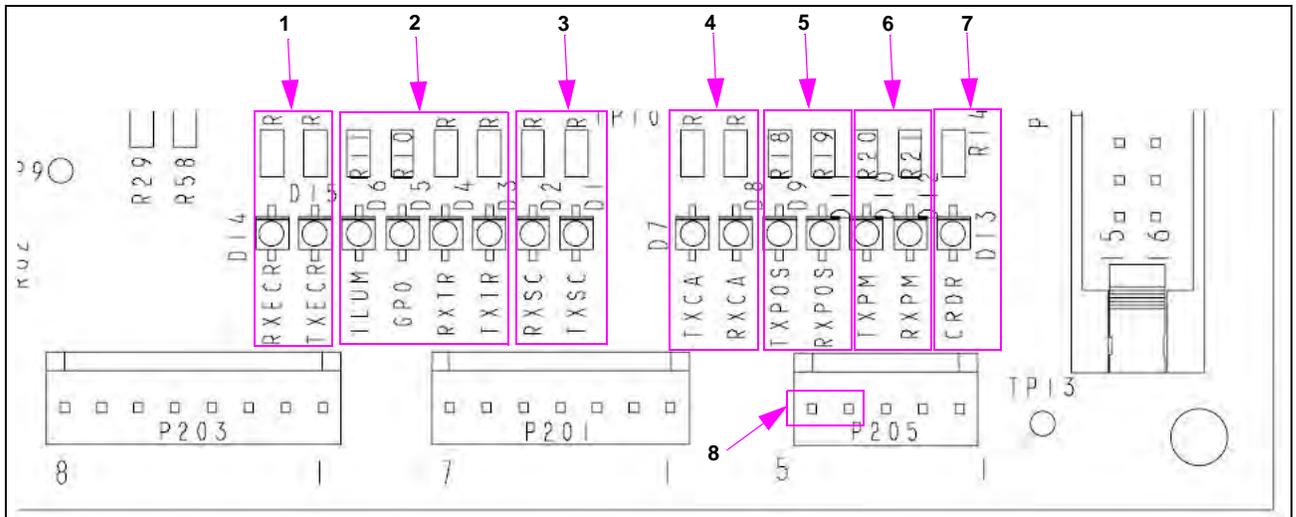
Figure 5 shows the SIP Board.

Figure 5: SIP Board

The general format of the labels is TX or RX, then the peripheral name is as listed in the table:
